# Harness Structural test Report

Inspection certificate number: **PH\_271.2019**
**Manufacturer data:**

Name: **Butterfly**  
 Type: **ABS**  
 Size: **Unique**  
 Serial number: **001**  
 Impact pad type: <sup>(1)</sup> **n/a**  
 Clip-in weight [kg]: **100**

Date of test: **16.04.2019**

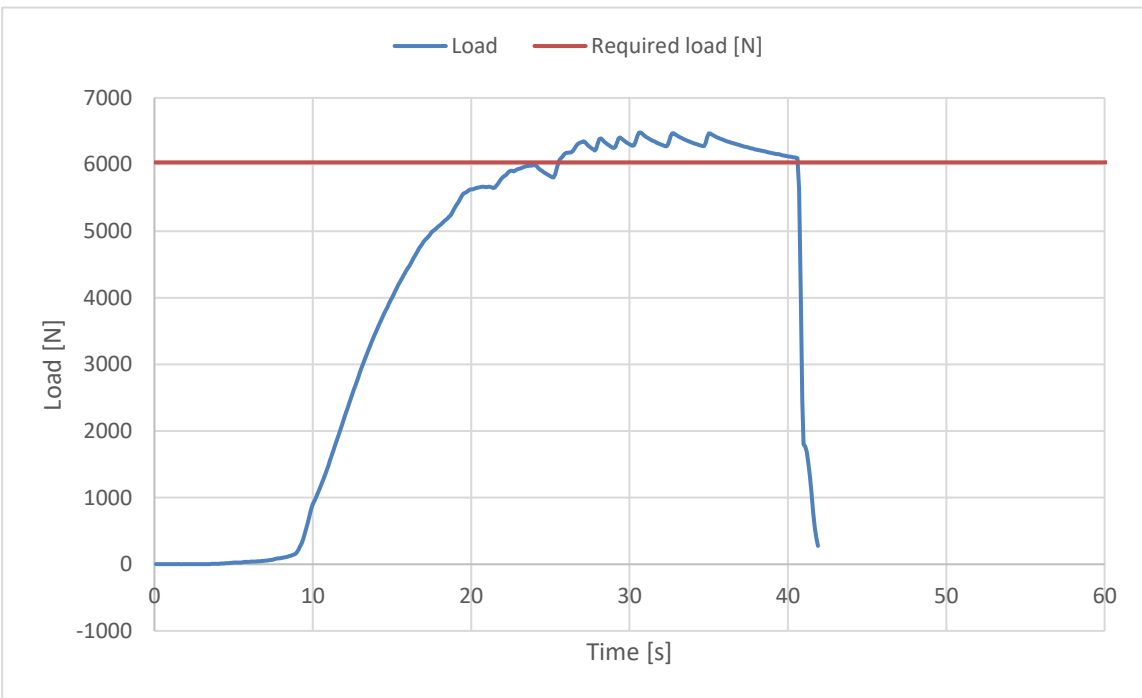
**Test ID R0**

Reference in standard	<b>5.3.2.1</b>	
Test setup	<b>Default flying position</b>	
Attachment points	<b>Both main riser attachment (3,4)</b>	
Anchor points	<b>Dummy (B1, B2)</b>	
Required load [g]	<b>6</b>	
Required load [N]	<b>6000</b>	
Minimum test duration [s]	<b>10</b>	
<b>Result</b>		
Test duration [s]	<b>15.1</b>	
Any signs of structural failure	<b>No</b>	
Test results	<b>POSITIVE</b>

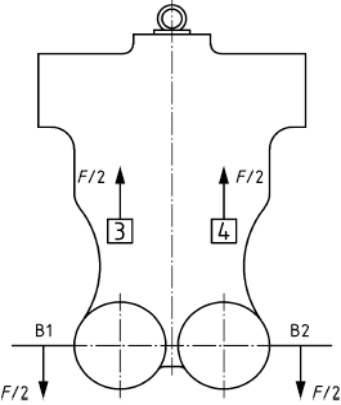
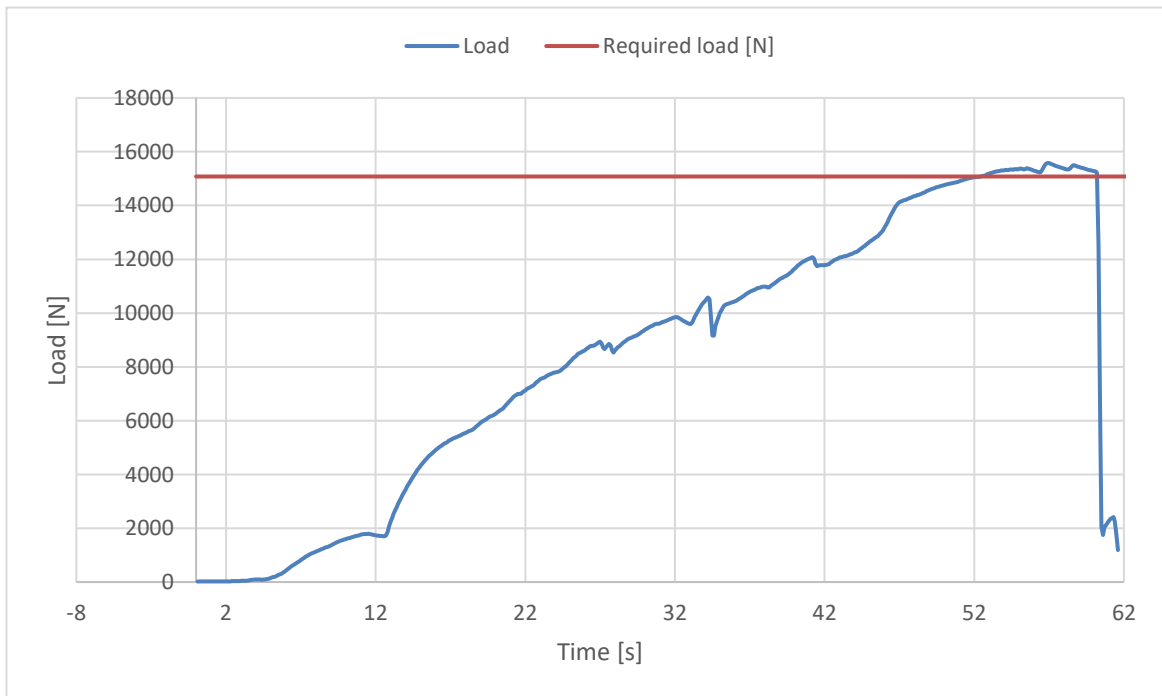
**Test ID R2**

Reference in standard	<b>5.3.2.2</b>	
Test setup	<b>Default flying position</b>	
Attachment points	<b>Both main riser attachment (3,4)</b>	
Anchor points	<b>Dummy (B1, B2)</b>	
Required load [g]	<b>15</b>	
Required load [N]	<b>15000</b>	
Minimum test duration [s]	<b>5</b>	
<b>Result</b>		
Test duration [s]	<b>7.8</b>	
Any signs of structural failure	<b>No</b>	
Test results	<b>POSITIVE</b>

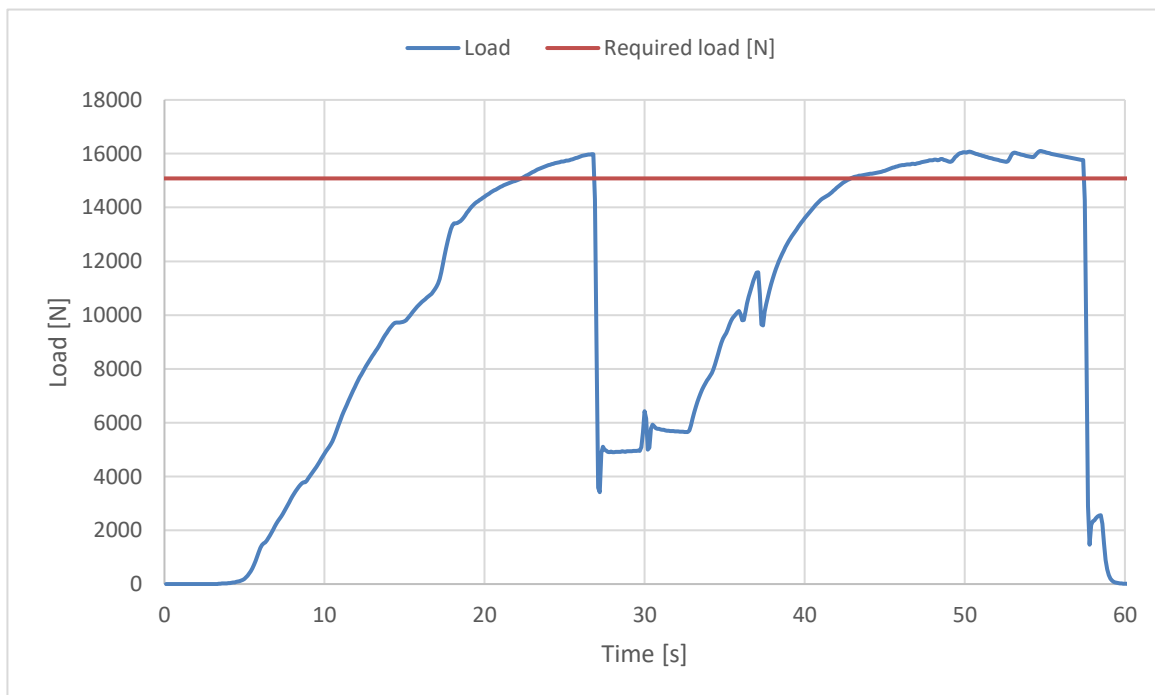
**Test ID R4**

Standard	<b>EN 1651:1999</b>
Reference in standard	<b>5.3.2.7</b>
Test setup	<b>Flying position before landing</b>
Attachment points	<b>Both main riser attachment (3,4)</b>
Anchor points	<b>Dummy (7,8)</b>
Required load [g]	<b>15</b>
Required load [N]	<b>15000</b>
Minimum test duration [s]	<b>5</b>
<b>Result</b>	
Test duration [s]	<b>14.6</b>
Any signs of structural failure	<b>No</b>
Test results	<b>POSITIVE</b>

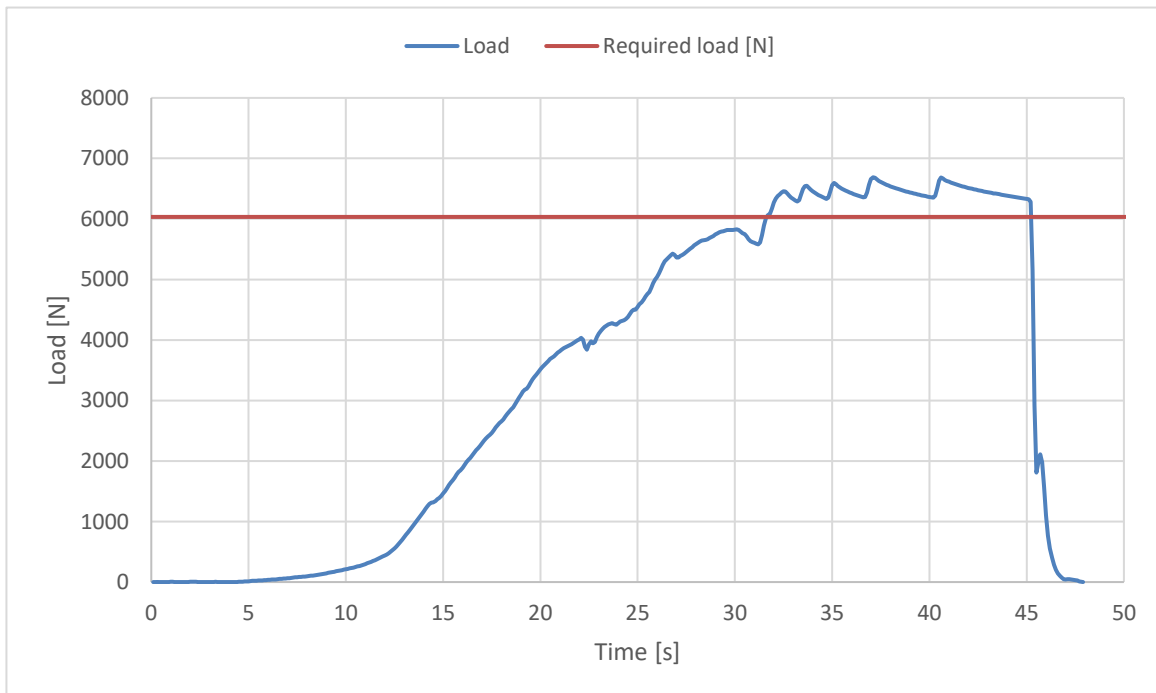
**Test ID R8**

Reference in standard	<b>5.3.2.3</b>	
Test setup	<b>Asymmetric, one riser</b>	
Attachment points	<b>One main riser attachment (3)</b>	
Anchor points	<b>Dummy (B1,B2)</b>	
Required load [g]	<b>6</b>	
Required load [N]	<b>6000</b>	
Minimum test duration [s]	<b>10</b>	
<b>Result</b>		
Test duration [s]	<b>13.6</b>	
Any signs of structural failure	<b>No</b>	
Test results	<b>POSITIVE</b>

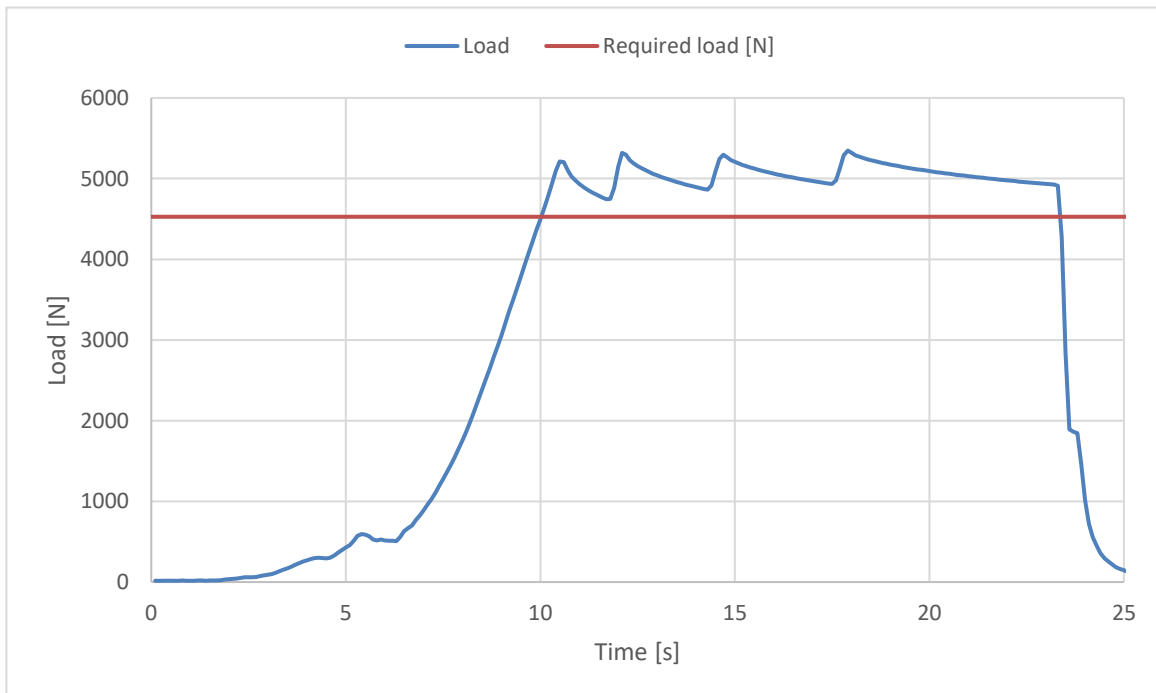
**Test ID R10**

Reference in standard	<b>5.3.2.6</b>	
Test setup	<b>Asymmetric, negative</b>	
Attachment points	<b>One main riser attachment (3 or 4) downwards</b>	
Anchor points	<b>Dummy (9)</b>	
Required load [g]	<b>4.5</b>	
Required load [N]	<b>4500</b>	
Minimum test duration [s]	<b>10</b>	
<b>Result</b>		
Test duration [s]	<b>13.3</b>	
Any signs of structural failure	<b>No</b>	
Test results	<b>POSITIVE</b>
